PROBLEM SOLVER™ BULLETIN

BULLETIN: 27010

Premature Ball Joint Failure

2002-2005 Jeep Liberty

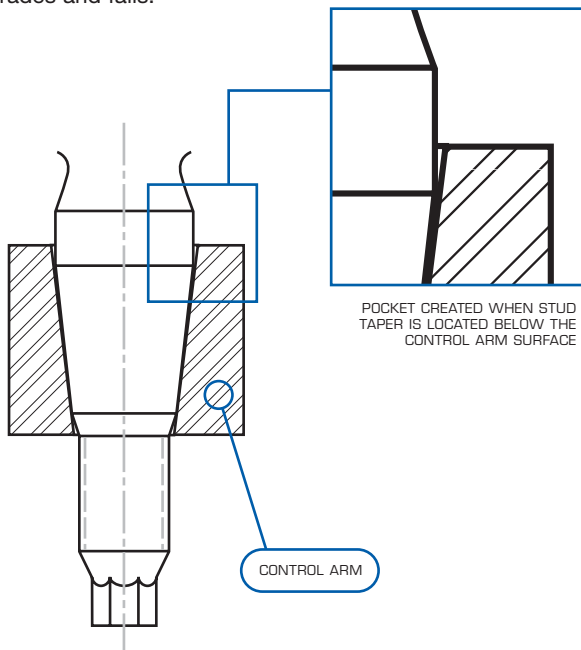
OE ball joint fails prematurely

Ball joint boot failures can cause corrosion, accelerated wear and possible joint separation. Failure can be traced to a slight gap between the ball joint stud and control arm. The gap or pocket accumulates moisture, promoting corrosion of the ball joint stud and control arm tapered hole. The corrosion generated by the pocket penetrates under the dust boot, wearing at the sealing surface of the boot. Once exposed to the elements, the sealed, non-serviceable ball joint quickly degrades and fails.
